Service Bulletin

19-011

January 31, 2019 Version 2

Safety Recall: 2016-18 MDX and 2015-19 TLX V6 Fuel Pump

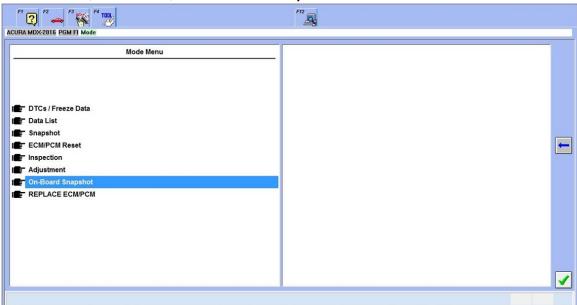
- 1. Connect the i-HDS to the vehicle, and turn the ignition to ON.
- 2. Select PGM-FI, Mode Menu, then On-Board Snapshot.

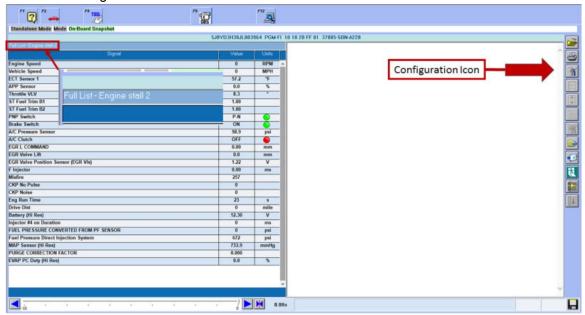
4. Select the Configuration icon.

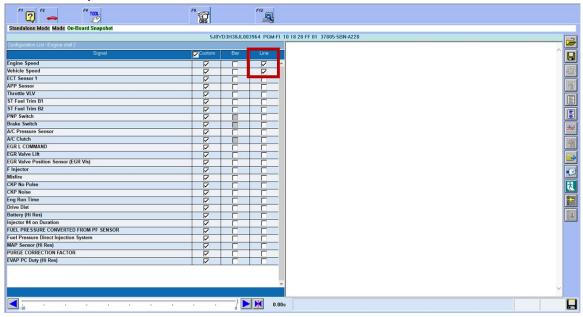
From the list of parameters, select the following:

- Engine Speed
- Vehicle Speed

5. Select the Line Graph icon. If **Engine Speed** is 0 RPM while **Vehicle Speed** is greater than 0 MPH, the engine stalled and you must do REPAIR PROCEDURE B - PGM-FI UPDATE AND FUEL PUMP REPLACEMENT.

- 2. Replace the low pressure fuel pump module located in the fuel tank. Refer to the service information.
- 3. Do the PCM idle learn procedure. Refer to the service information.
